Why do Desiccant Rotors Fail?

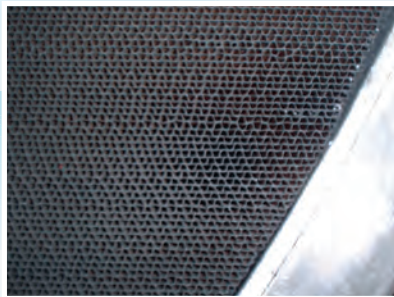
Normal Appearance of Rotor Face

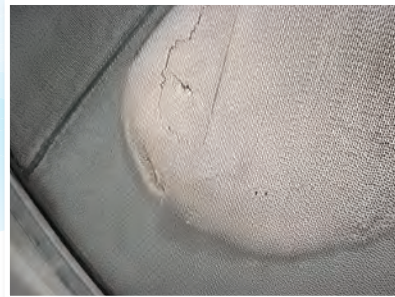
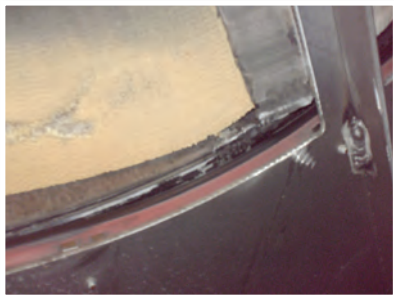
Overheated Rotor Appearance

- › Caused by chronic exposure to reactivation temperatures in excess of the substrate media tolerance.
- › Symptoms include beige, pink, or white areas on the face of the desiccant rotor.
- › Brittle or powdery to the touch.
- › High temperature causes breakdown of surface face-hardening, causing erosion of the media from the reactivation entering/process air leaving side of the rotor.
- › Once the face of the rotor has been overheated, mechanical failure is certain and replacement or refurbishment is required.
- › Caused by improper reactivation burner set-up, lack of reactivation airflow, control system failure, poor filter maintenance, and/or failure of rotor drive system.

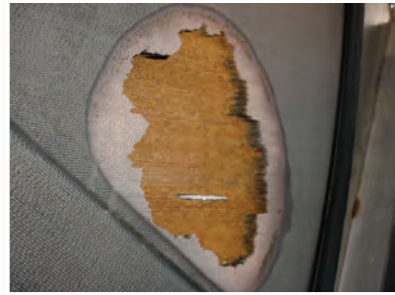
Ultimate Failure

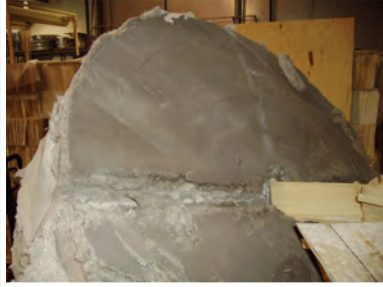
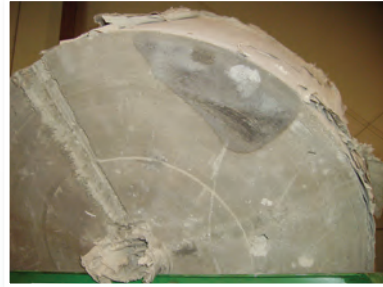
Chronic Under-temp Rotor Appearance

- › Caused by high moisture loads with inadequate reactivation energy.
- › Chronic condensation within the rotor weakens substrate and causes breakdown of the process air entering/reactivation air leaving side of the rotor.
- › Soft or mushy to the touch. Might appear grey to black in color (mold). Often shows severe grooves.
- › Most prevalent with deeper (400 mm) rotors.
- › Caused by failure of reactivation modulation (stuck on low-fire), control system failure, pre-cooling or outdoor air mist carry-over into the rotor.

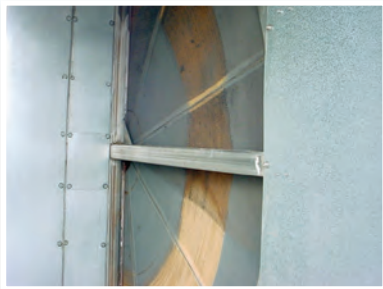
Mechanical Failure Rotor Appearance

- › Caused by careless maintenance personnel bumping into the desiccant media.
- › Can be caused by poor filter maintenance. When filters become overloaded they can be pulled through their frames by static pressure and into the desiccant media where they slowly erode the face hardening or jamb between the rotor and the sector seals.
- › Characterized by rotational shaped damage and no discoloration of the face.
- › Media from certain manufacturers can also suffer from catastrophic brittle failure where large pieces of media can separate from the rotor structure. These propagate from cracks that might be caused by vibration in shipment. Cracks can be stabilized if found early.

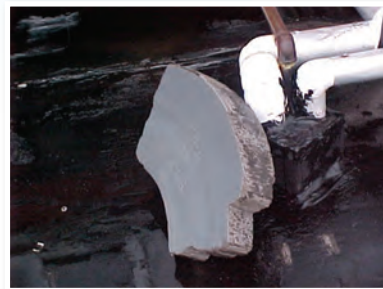
Catastrophic Media Failure
