Ice Arena Construction and Dehumidification

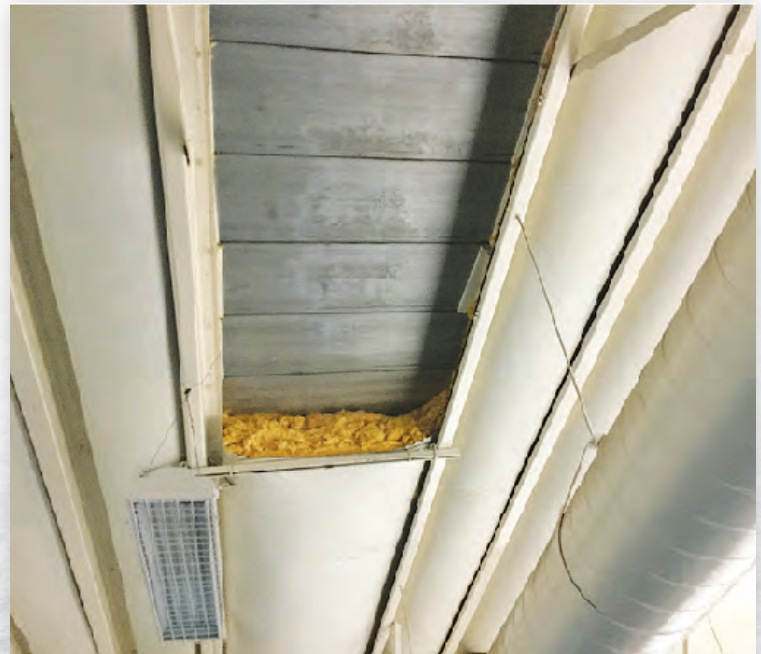
We accept that leaks in the arena are inevitable. That's why a dehumidifier is needed. In a simple sense, the moisture that leaks in is removed by the dehumidifier. If the dehumidifier is

large enough for the prevailing leak-rate and as long as the vapor that leaks in can dissipate into the dry air in the arena, all is well. However, anything that impedes moisture from easily dissipating into the dry arena results in condensation if that moisture-laden air cools to its dewpoint. It is important that the humid air leaking into the arena have a free pathway into the dry arena. It has to dissipate before it cools to its dewpoint.

extend wall to wall. This would merely recreate a problem above the new ceiling! A margin around the perimeter is necessary to allow moisture above it to easily dissipate into the dry air below it (*see photo*).

- **Cut a 1-1/2' to 2' margin around the perimeter of the insulation to expose the wall to ceiling joint.** This exposed margin will then permit moisture that leaks in to readily breathe into the dry arena (*see photo*). The exposed roof deck can be reinsulated with impermeable rigid insulation or spray-foam. This solution presupposes that the source of moisture vapor is at the wall to ceiling joint. If your arena is one of those that also has mechanical "things" mounted on the roof above the ice, you will need to ponder how to address those leaks.

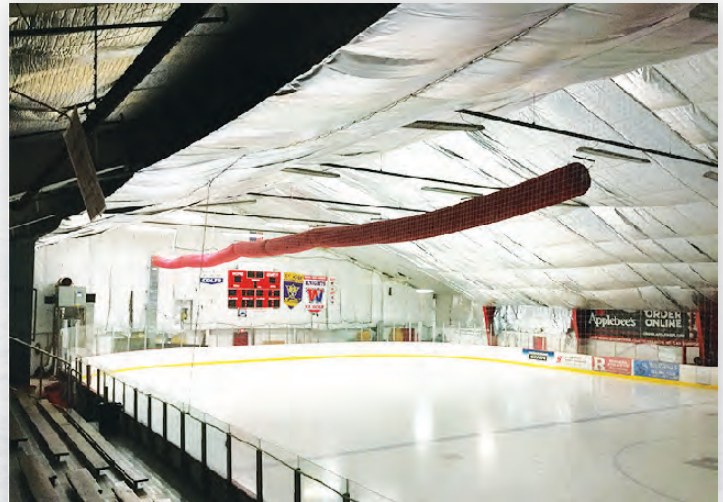
- **Install a low-emissivity ceiling below the existing ceiling in order to interrupt the heat transfer pathway from the ceiling to the ice.** In practice, this is a dubious solution because it is not likely to completely solve the problem. The intent is to keep the existing ceiling warm enough to inhibit condensation of trapped moisture within the batt insulation. Unfortunately, in summertime, the dewpoint of outdoor air can be in the low to mid-seventies degree F range, so it does not take much cooling to cause condensation. If this approach is taken, it is important that the Low-E ceiling membrane does not
